AFRL-ML-WP-TR-2001-4162

**AUTOMATED CORROSION DETECTION
PROGRAM**

**University of Dayton Research Institute
300 College Park Avenue
Dayton, OH 45469-0120**

FINAL REPORT FOR 07 APRIL 1997 – 06 OCTOBER 2001

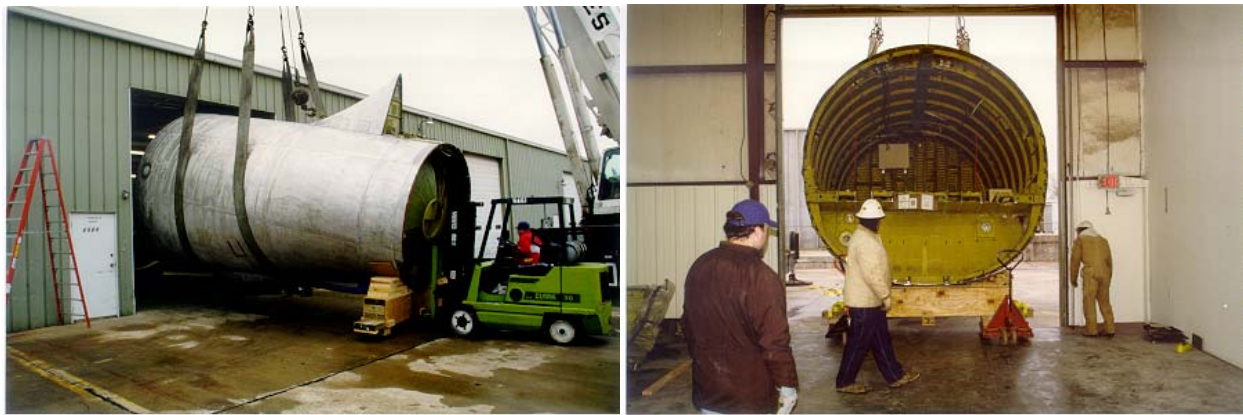
Figure 33. Section of KC-135 Entering the DTEF (outside view/inside view)

The facility is dedicated to the support of the ACDP, and during the term of the ACDP, is available for use by government, commercial and academic participants for NDE research involving corrosion and other damage relative to the aging KC-135 fleet. In this way, the DTEF provides diversity to the aging systems community and has the potential of providing a basis for expansion of related academic curricula. Figure 33 shows a KL-135 tail section being moved into the facility. Figure 34 shows this tail section in a fixture within the facility.

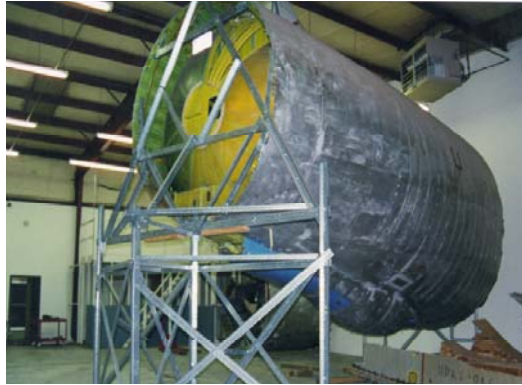
Figure 34. Working in the DTEF
